**[Subject] Conformity declaration Zinc Aluminium**

**Salt Spray Accelerated Corrosion - Test Report**

Test Report Number : **S18519**  
 Date Specimens Received : 12.08.19  
 Date Test Report Issued : 30.09.19  
 Purchase Order No. : PO-0010750

Specification and Test Method : BS EN ISO 9227 and ASTM B117  
 Test Specimen(s) Description : 135g/m<sup>2</sup> Wire cable tray section 300mm long.  
 BS EN 61537:2007 and BS EN 1461:2009 Class 6.

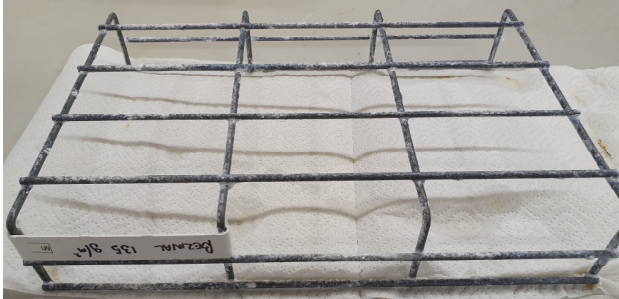
Sample No.	Exposure (hrs)	Images
M1	168

Treatment	Requirement	Exposure (hr)	Test Specimen Condition after Exposure
Benzinal	Run to 550hrs, then run to fail and record hours	168	Clean and free of red corrosion.
		240	Clean and free of red corrosion.
		576	Clean and free of red corrosion.
		1104	Heavy white corrosion, clean and free of red corrosion. Part removed from test as requested.
			<i>Passed to Marco Cable Management for final assessment</i>
